### TerraVerde Energy

### Today's Session:

#### BEST PRACTICES IN MANAGING SOLAR ASSETS

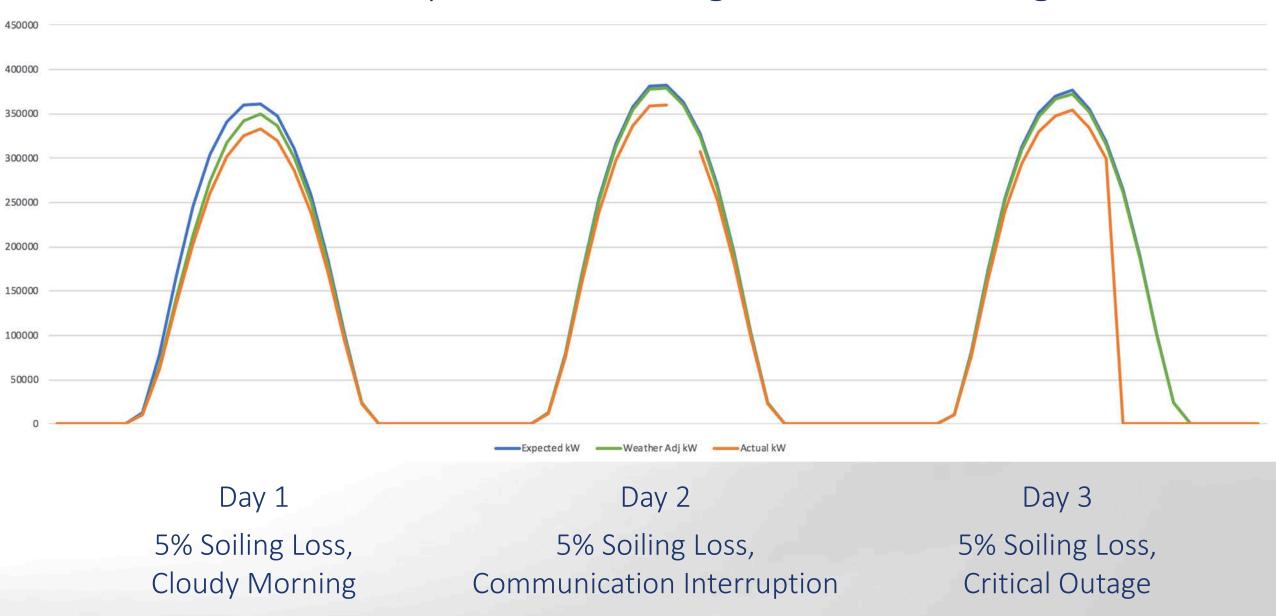
### **EXAMPLE** | Understanding Solar Monitoring

- Daily reviews of prior day's performance with actual, expected, & weather adjusted data
- Daily review of open alerts
- Early detection of outages / underperformance is key
- Validate accuracy of metering and monitoring hardware / software
- Establish accurate baselines

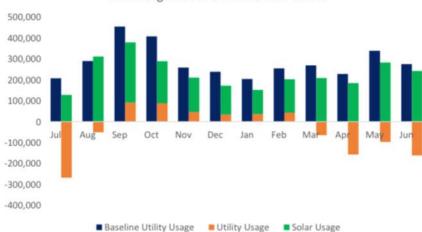
#### Client Phase I Total

Utility Usage Relative to Baseline: -113.5% Total Usage Relative to Baseline: -16.6%

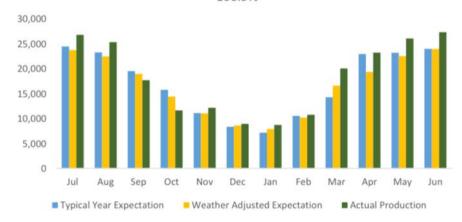
Site: SITE 1

Solar Energy Production Relative to Expectations: 106.9%
